New York State Department of Transportation

PIA Safety Flag NB23U4W001

BIN: 1065318

Feature Carried: 278I278IX2M23027

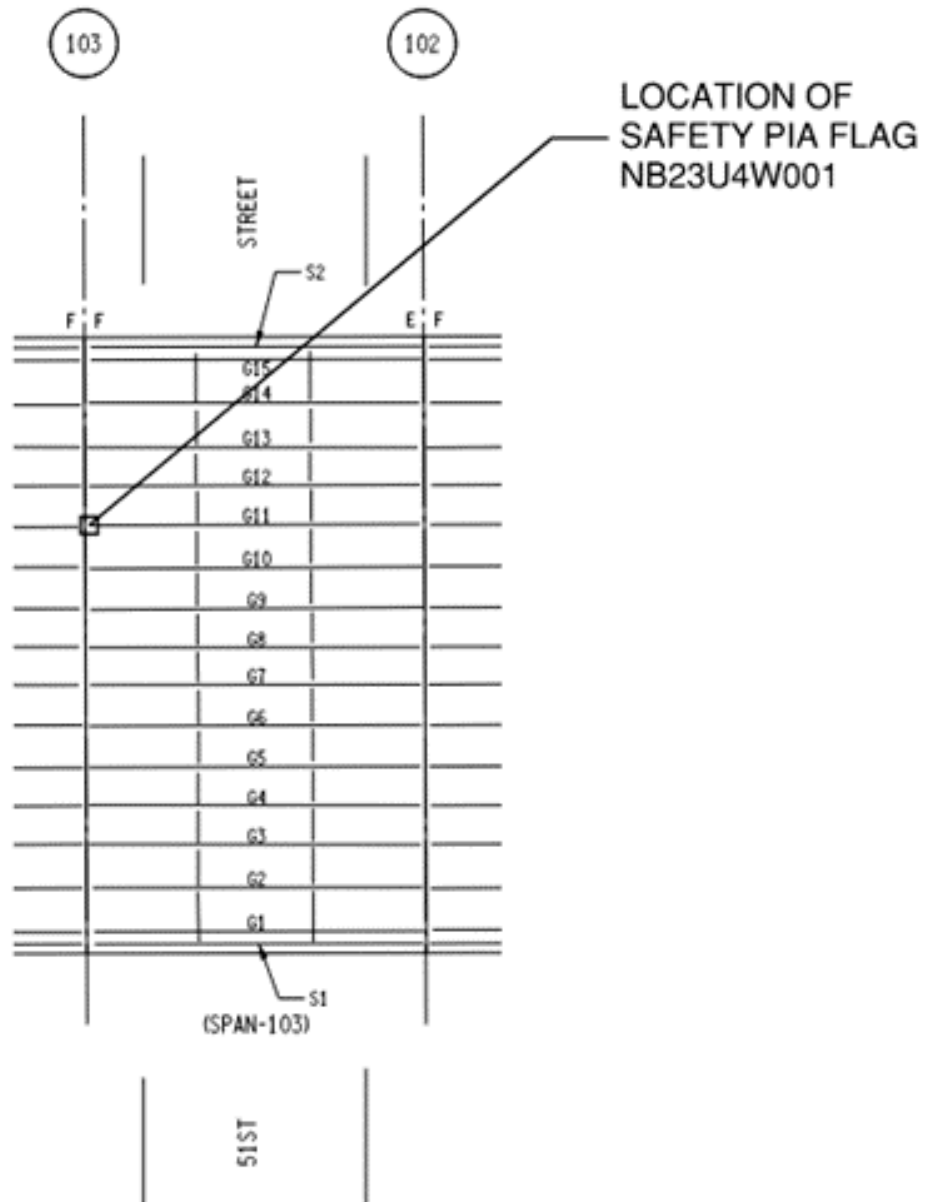
Photo Number: 1

Location: Span 103, Pier 103, Column C2 begin face (51st Street and 3rd Avenue intersection).

**Attachment Description: Safety PIA Flag Location**

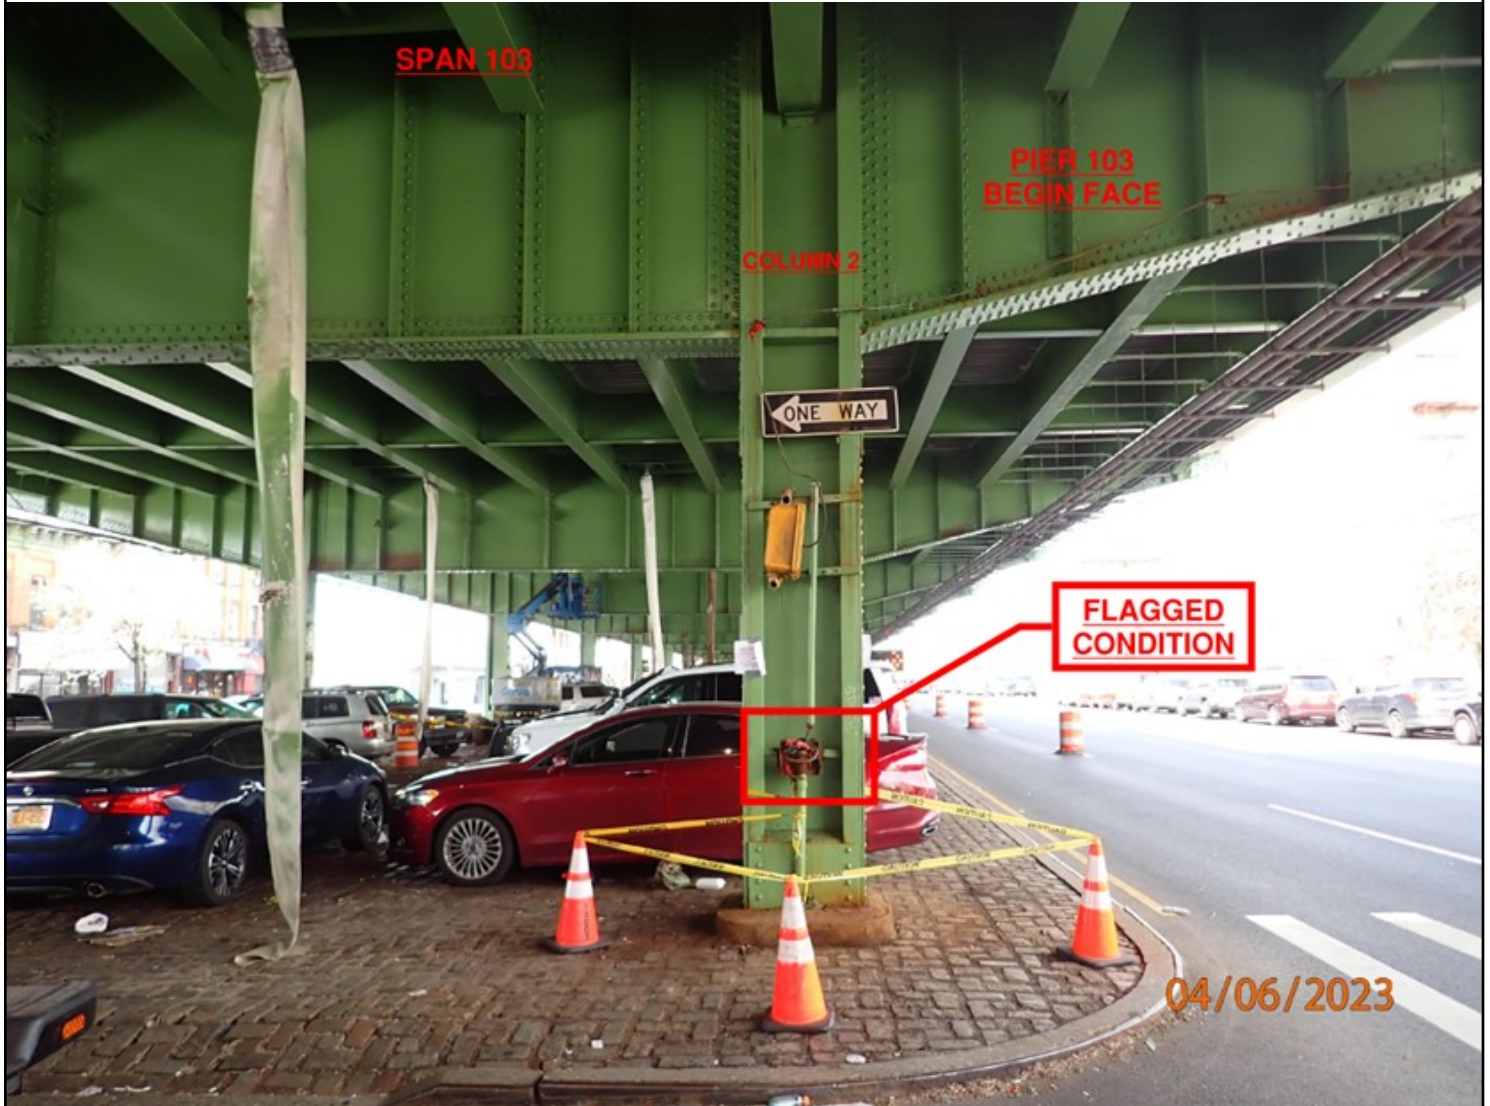
Photo Number: 2

Attachment Description: General view of the flagged condition under Span 103, column C2 at Pier 103. Looking End.

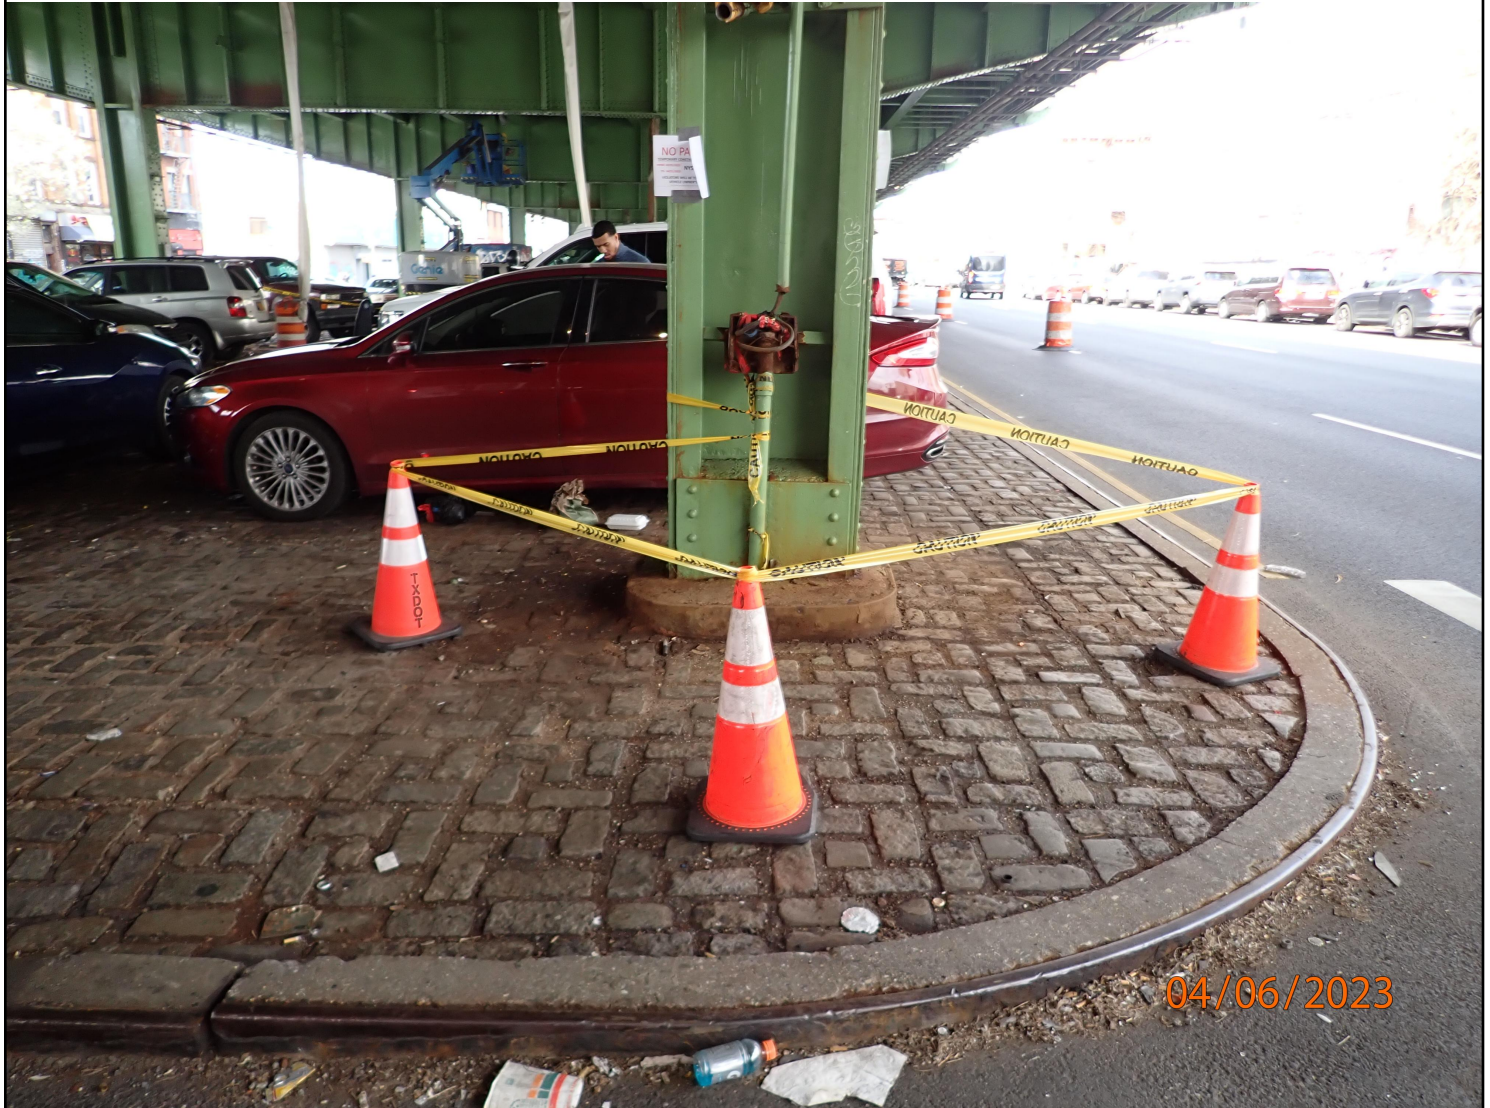
Photo Number: 3

Description: The junction box for the traffic light and attached to Column C2 is broken with exposed electric wires. This location is located at 3' above the ground on the sidewalk and can be accessed by walking. The area is temporarily secured with cones and caution tape.

Attachment Description: The sidewalk at the begin face of column 2 of Pier 103 under Span 103. The electrical junction box is broken with exposed wires. The area has been coned off with yellow caution tape. Looking End.

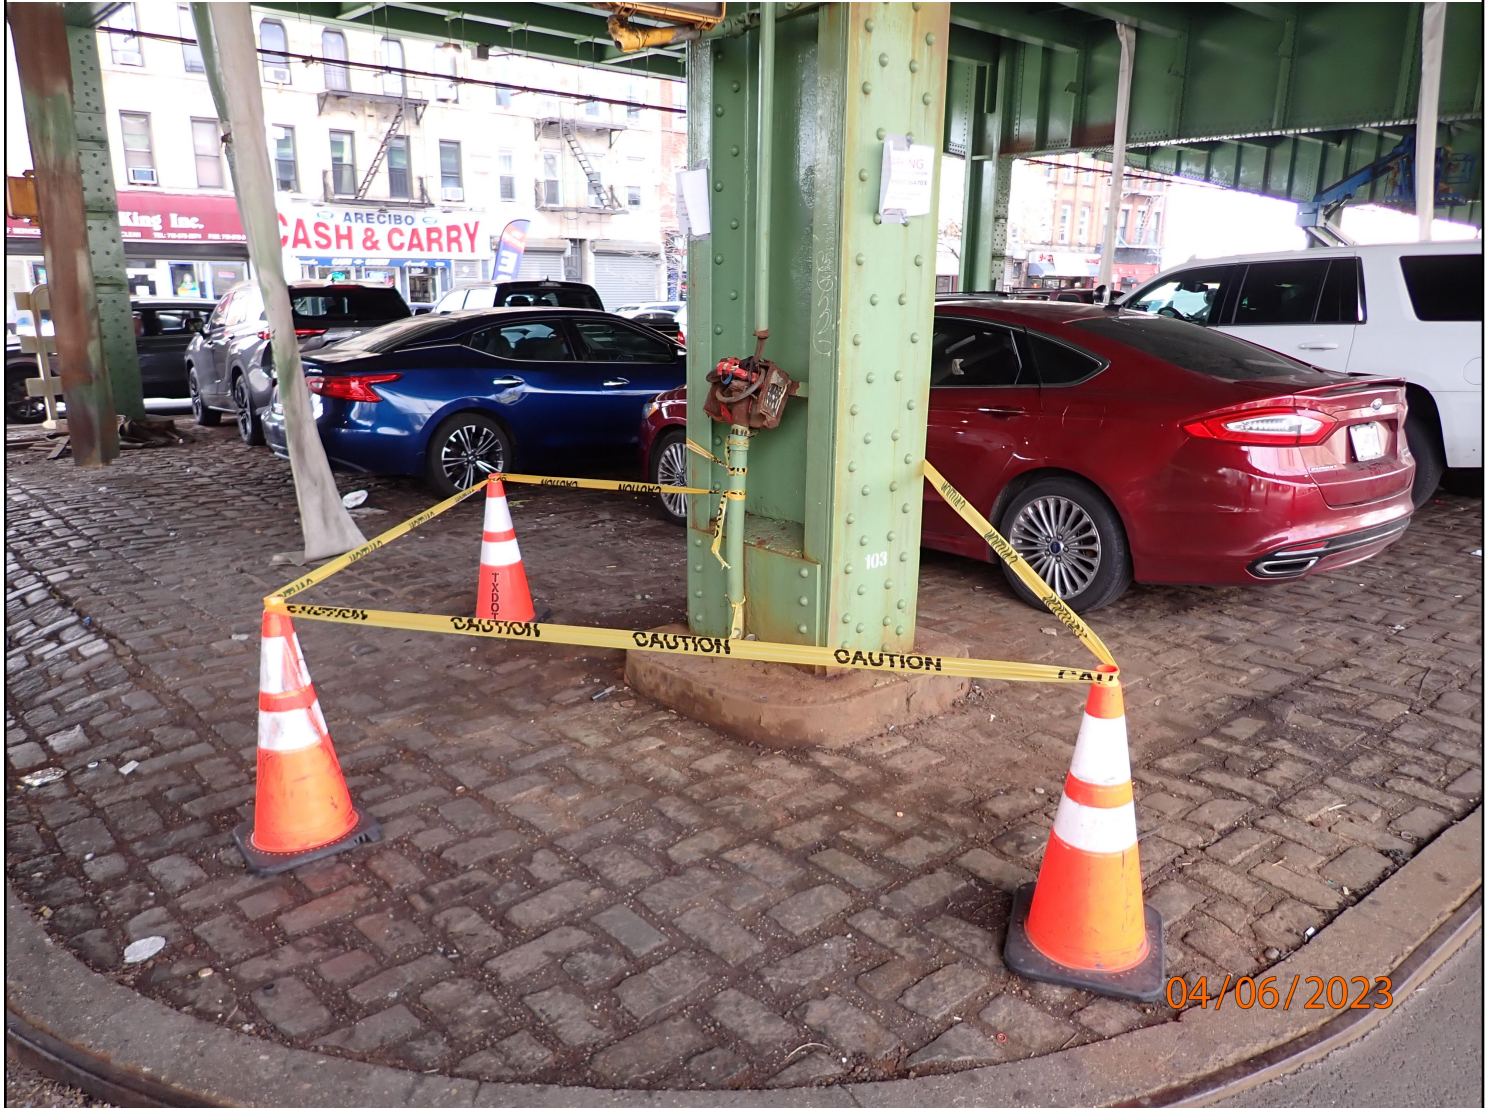
Photo Number: 4

Attachment Description: The sidewalk at the begin face of column 2 of Pier 103 under Span 103. The electrical junction box is broken with exposed wires. The area has been coned off with yellow caution tape. Looking End-left.

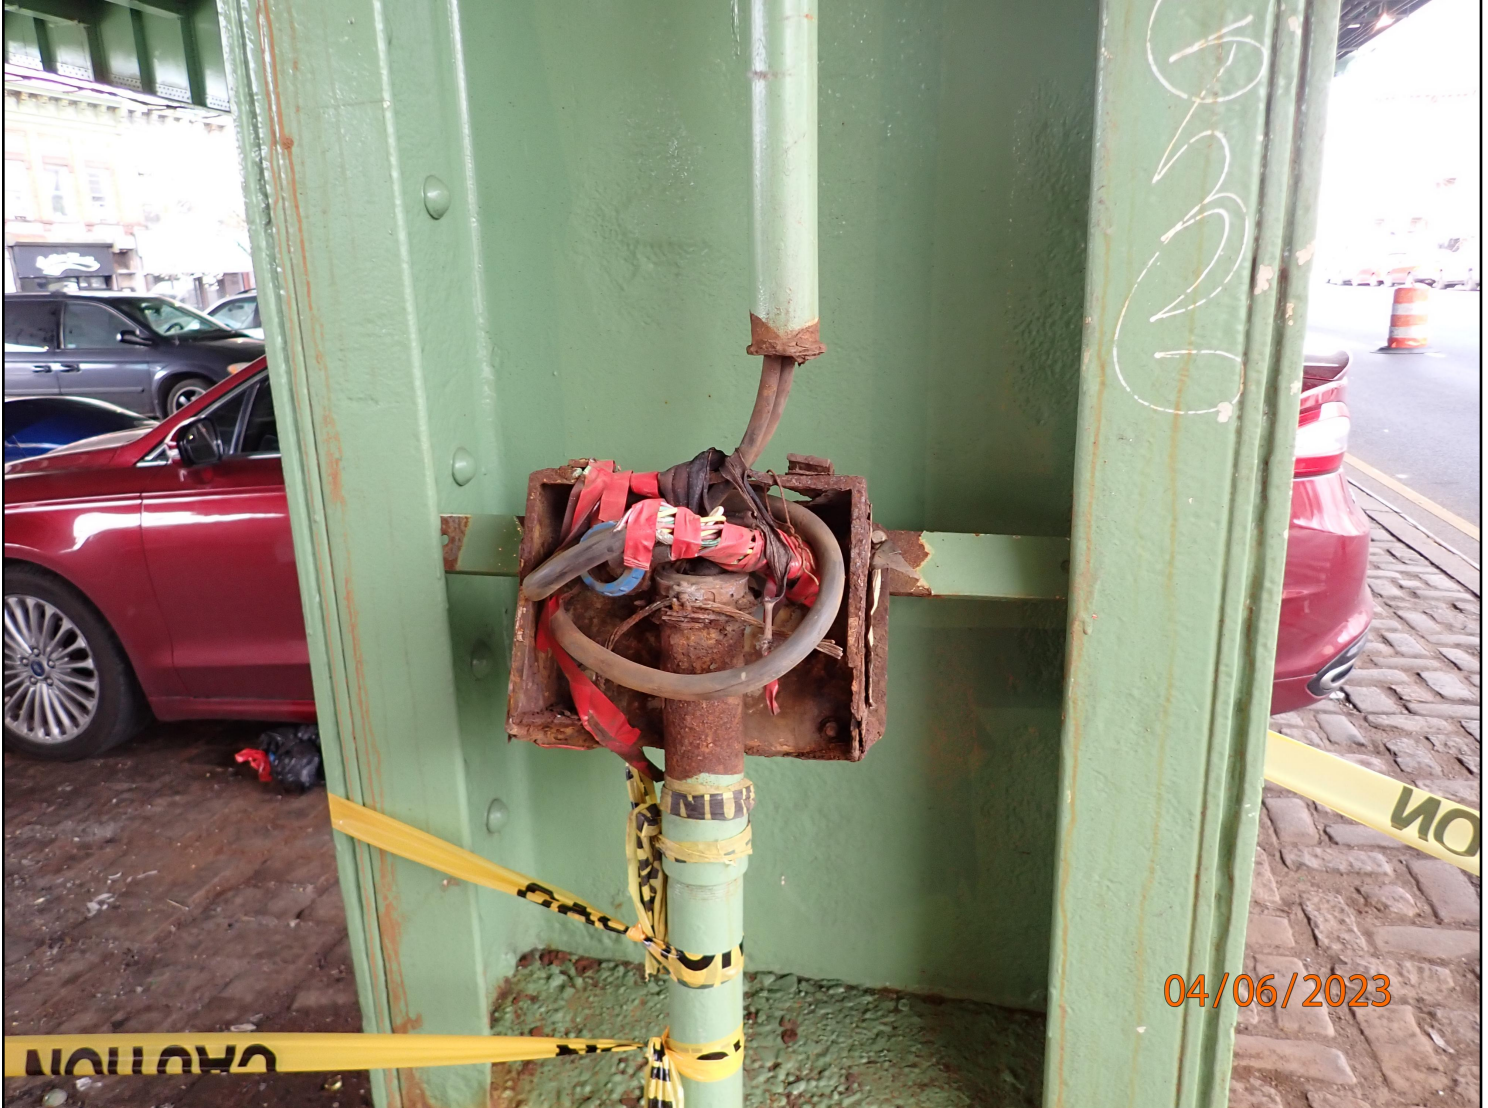
Photo Number: 5

Attachment Description: Close-up view of the broken electrical junction box with exposed wires. The area has been coned off with yellow caution tape. Looking End.
